## The Latest from Virginia Beach History Museums

### **Lynnhaven House Restoration Status**

### **Francis Land House Restorations to Begin in Mid-July**

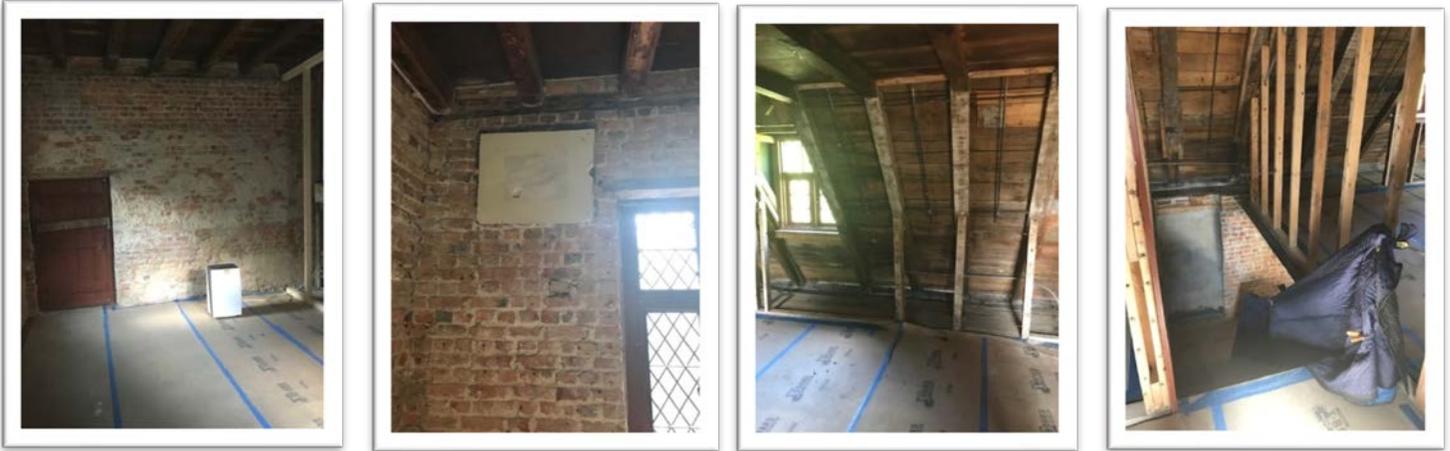
Some recent photos from the Lynnhaven House restoration:

1. Removing the plaster and metal lathe work in its entirety from the masonry

walls, rafters/ceiling joists, knee walls, and interior dormers. These materials will be removed from the site and disposed of in accordance with local regulations.

The architect informed us that the plaster is being removed so the brick walls can dry out with a few seasons of the new mechanical system dehumidifying. At one time they were going to reinstall the plaster sooner, but it was recommended by Watson & Henry (consultant on mechanical/environmental systems in historic buildings) to let it dry out for a few seasons.

The old plaster was trapping moisture behind the plaster, keeping the brick wet and the mortar was starting to fail. The next step, in approximately 6 months-1 year after completion, is to repoint the interior brick where needed, then apply the new plaster on furring. There is a specialized plaster that can handle the saltwater that gets driven into the brick from the exterior. In construction, furring are thin strips of wood or other material to level or raise surfaces of another material to prevent dampness, to make space for insulation, or to level and resurface ceilings or walls. Furring refers to the process of installing the strips and to the strips themselves.
